LIVE SCREW CAUSES ELECTRIC SHOCK ON BUILDING SITE

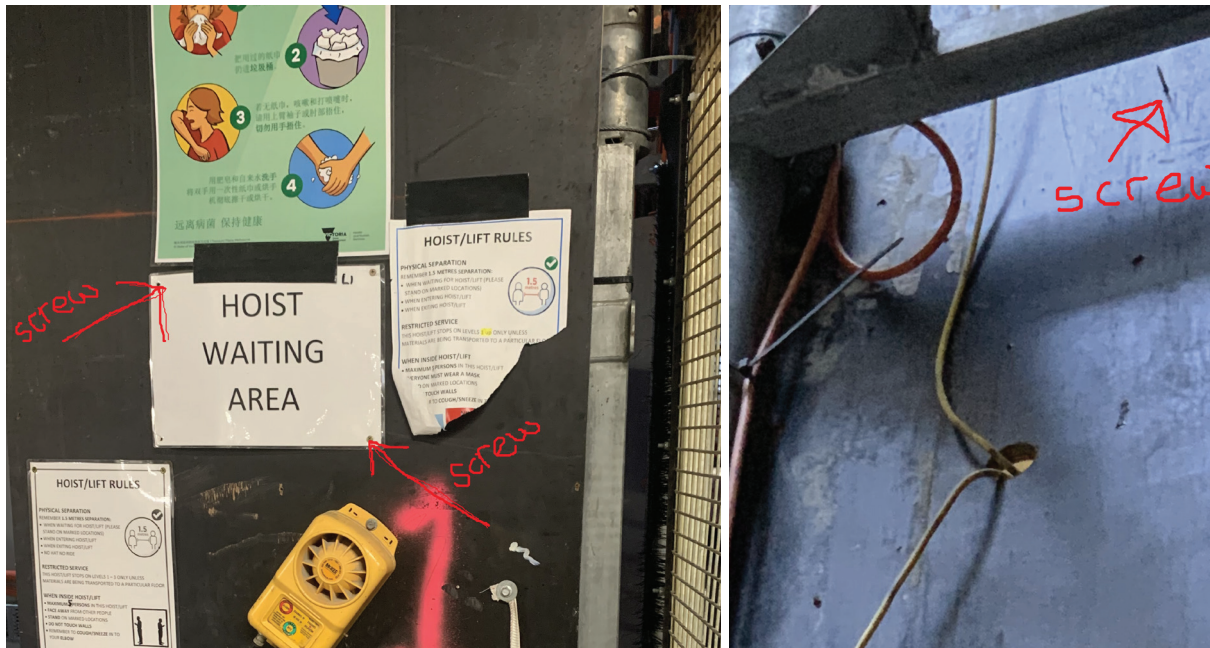
On Tuesday the 10th of November a worker on a building site in Melbourne received an electric shock after touching a screw while waiting for an Alimak. The screw, which was holding up laminated COVID-safe signage, went through a timber wall and penetrated an active live cable (see orange cable in photo above).

The worker was not seriously injured but was taken to hospital for assessment.

All sites should conduct a site audit with your safety committee, including your CFMEU and PPTEU delegates, on all hoists and any other wall that has live cables behind it. Check all screws, fixings and penetrations to ensure nothing is live.

Moving forward hoist companies and site management will need to ensure that cables are as far away as practicable from any wall likely to need signage screwed into it.

Warning signage must be installed where live cables are already located behind a wall if the cables can't be relocated.
