INSULATED PINS ON 3 PIN PLUG TOPS

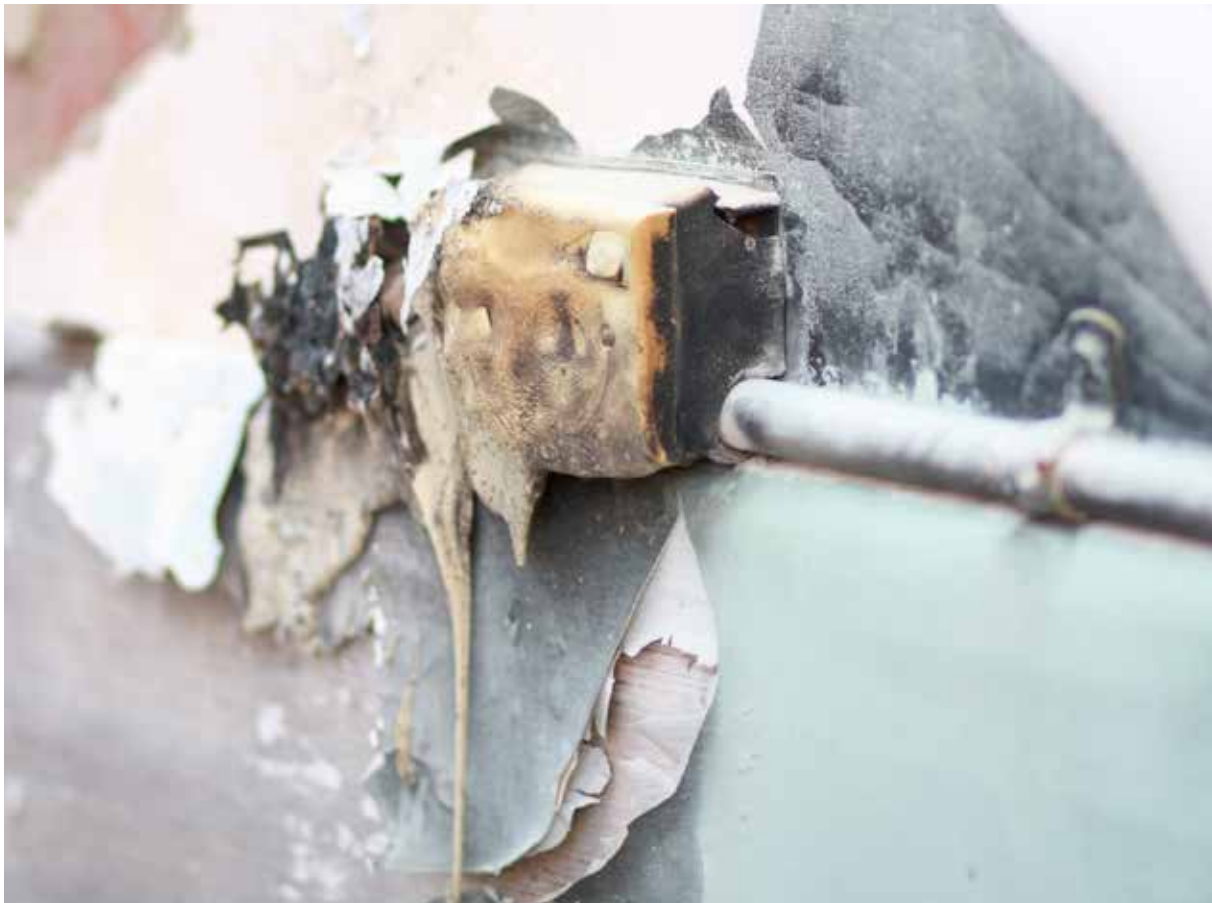
It appears that there was a fundamental design flaw when the pins on 3 pin plug tops were narrowed to allow for insulating medium to be installed to provide protection against inadvertent contact.

In some circumstances, this caused the pins to snap off at the plug top, and in some instances, the pin remained in the socket outlet.

There is no way of identifying the plug tops with potential problems, against those that have been manufactured to the amended test regime.

This is a reminder that we must be ever vigilant and inspect all electrical equipment prior to use and assess whether there may be anything located in the socket opening.

Where it is established that easy extraction of pins is not possible, the socket outlet should be replaced.
