REBAR CAPS DO NOT PREVENT IMPALEMENT

The purpose of this alert is to advise employers and employees of the dangers of falling against exposed reinforcement bars, even if they have plastic protective cover, (rebar-caps) attached. It also provides advice to suppliers of rebar-caps.

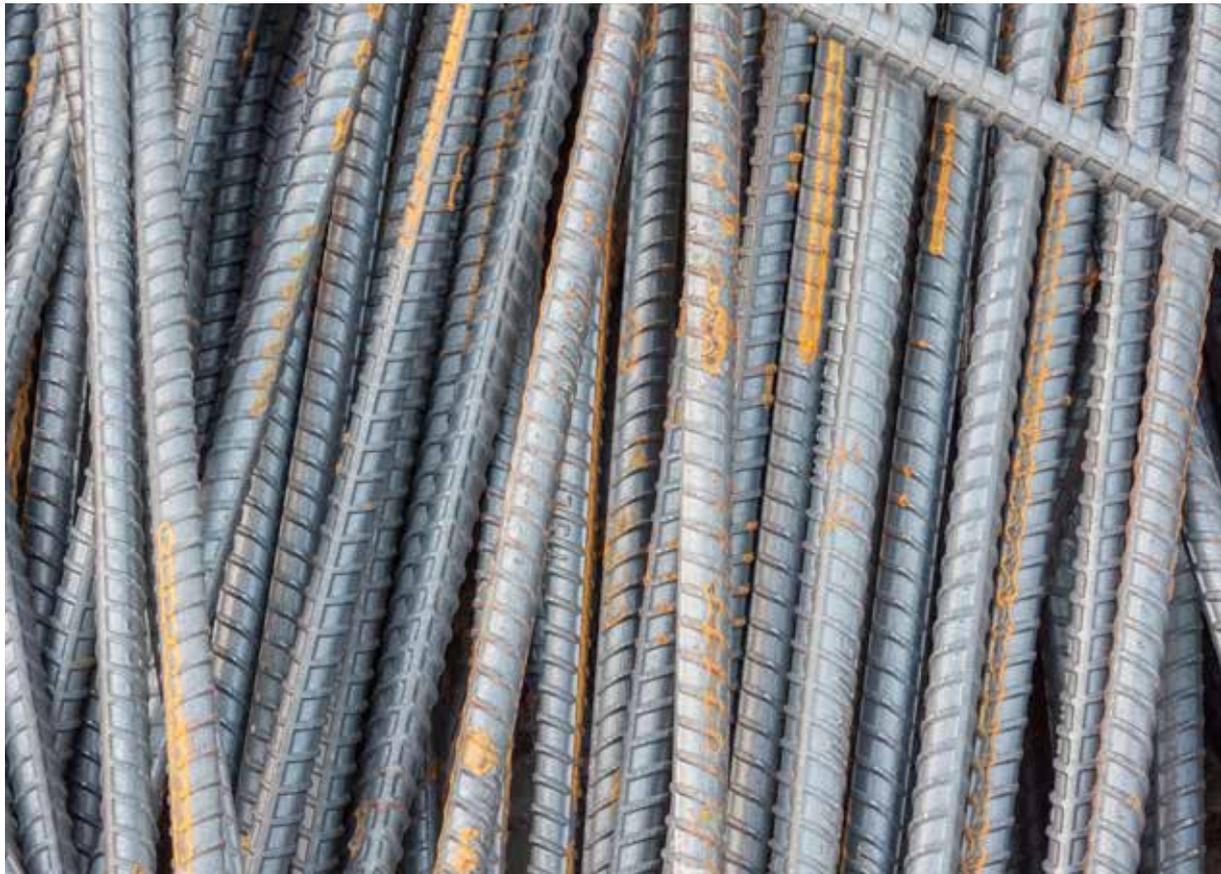
An incident occurred in NSW in which a person stumbled and fell, impaling himself on an exposed reinforcement bar. The bar had a rebar-cap on it, but the cap offered no protection against impalement as the weight of the worker was sufficient to be pierced by the bar.

Research carried out following the incident included tests that involved dropping a 20kg bag of sand one metre onto a vertical reinforcement bar. This showed that standard rebar-caps provide little, if any, protection against impalement by falling against them or even a fall from the same level. Any protection offered by the caps, no matter how slight, was greatly reduced if they were the wrong size for the bar, or were incorrectly fitted.

Where this is not possible, workers should be effectively separated from the exposed bars by guardrails, screens or other means. Where workers are on scaffolds adjacent to exposed reinforcement bars, the scaffold should be fitted with edge protection regardless of their height.

Where it is necessary for work to be done adjacent to exposed reinforcement bars, rebar-caps should be fitted on top, taking into account the following;

- use rebar-caps offering some level of protection against impalement;
- use the correct rebar-cap for the size of the bar;
- fit rebar-caps properly in accordance with the supplier's instructions;
- check the condition of the rebar-caps, especially for deterioration from exposure to UV light; and
- regularly check the rebar-caps are still in place and correctly fitted.
