## SCISSOR LIFT INCIDENT: DE-GLOVING

The incident occurred on the 6/4/17, on a construction site in Melbourne:

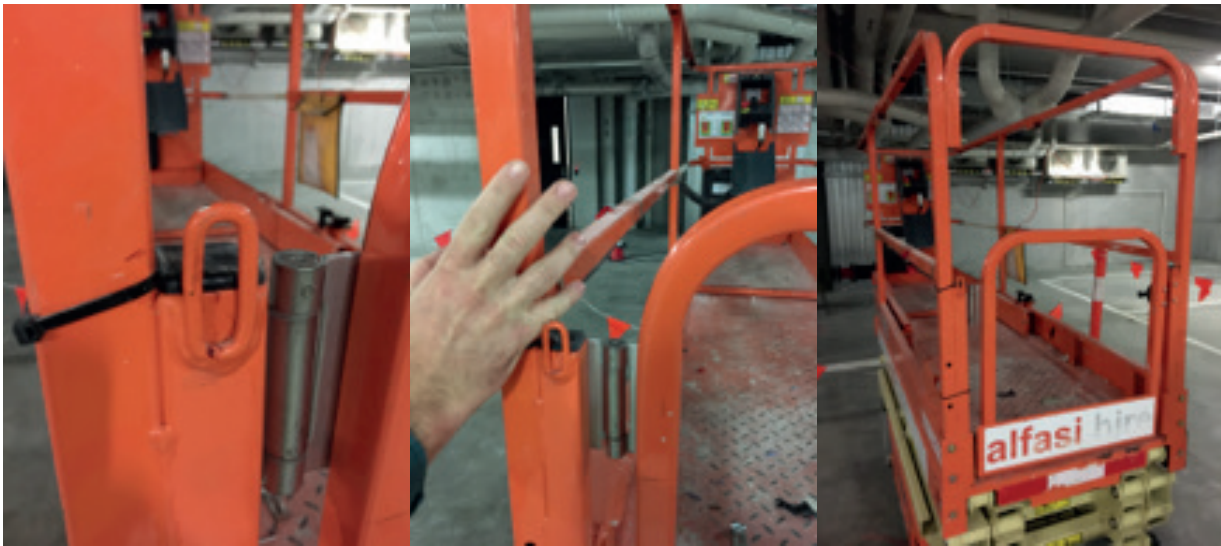
**A serious injury occurred where an electrical worker had his 'pinkie' finger de-gloved as a result of an incident whilst exiting a scissor lift. The injured person required a skin graft to the finger to repair the significant damage. The details of the incident were as follows:**

- The injured person was exiting the scissor lift backwards until he reached the final step. At this point he took hold of the left frame of the scissor lift with his right hand, turned to his left and hopped off the last step to the ground.
- As the injured person hopped off the last step his finger became jammed between the frame of the scissor lift and the chain link welded onto it, resulting in the skin of his finger being pulled completely off (de-gloved).

- Immediate Control: Tape around link and frame
- Long Term Control: Remove links upon approval from supplier / manufacturer

It is the recommendation of the ETU that scissor lifts that have the chain link in a position that can enable entrapment, be taken out of service until the immediate control is in place. For more information contact your designated Health & Safety Representative, your local organiser or alternatively your Union OH&S Officer.
