Faulty non compliant equipment and accessories.

OH&S SAFETY ALERT

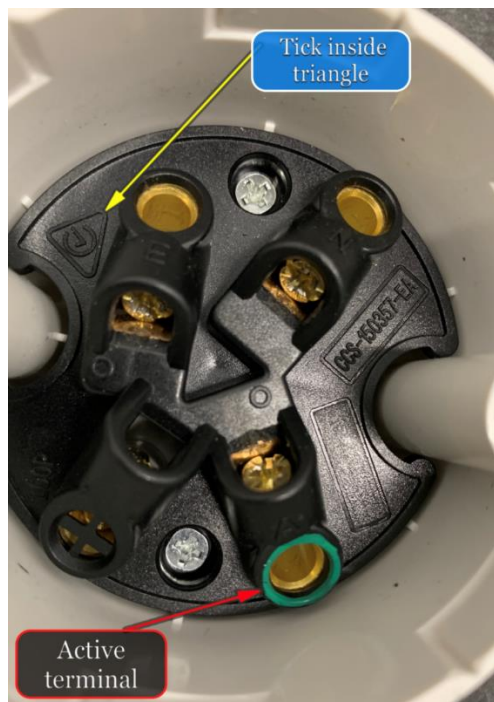
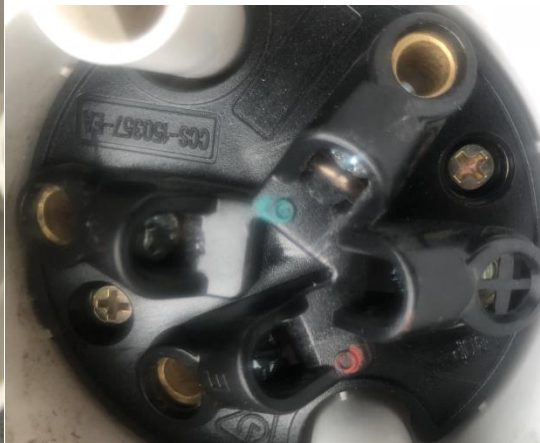
On several occasions we have found faulty accessories. See the pics below of 413 surface sockets with a painted green ring around the active terminal connection. Note that on most of these 413'S the green ring is correct at the earth terminal but some are wrong and have the green ring around the active terminal which is causing all sorts of issues and has the potential to cause serious harm or death. This is obviously a mistake during the manufacturing process. We have strict testing requirements and legislation for a reason. We need to check the whole electrical installation, every piece of equipment and every accessory in order to ensure safety and compliance.

Do not to install anything that doesn't meet Australian Standards. If you are not sure, check online for standards compliance or check with the site HSR or EnergySafe.

All Electricians need to be reminded that the onus is on the electrician who signs the CES to ensure that the installation is safe and meets all relevant standards and safety requirements.
