SHERRIN VEHICLE-MOUNTED 16m EWP MODEL NO. 16DPM52

Sherrin vehicle mounted 16m EWP model No. 16DPM52 AU

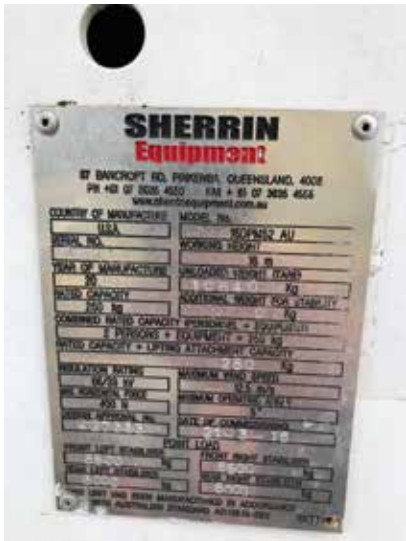
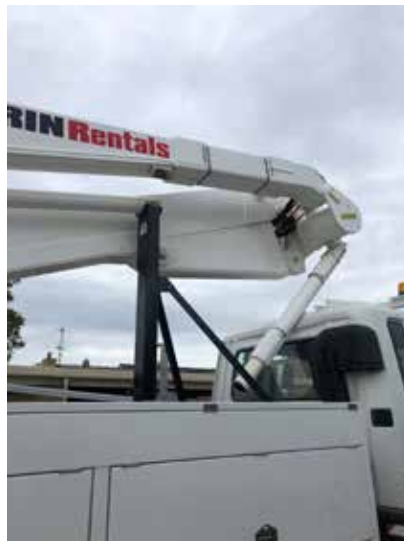
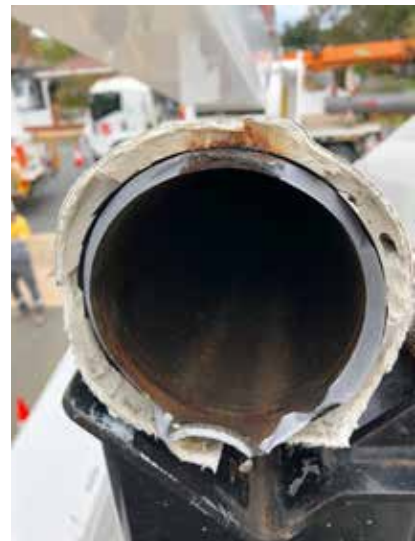
As the employee was lowering the EWP basket, the compensating rod has failed and as a result the EWP basket entered into an uncontrolled fall of approximately two (2) metres. The fall stopped when the EWP boom landed on the boom stowing bracket. The employee was correctly wearing his safety harness and was attached and remained within the EWP basket during the fall.

The ETU strongly recommends that all EWP's of this model immediately be tagged out and classed as unfit for service until checked by an independent expert in this type of plant and deemed safe for use, in writing.
