Tripod Type Pole Stands (Dead Man's Stands)

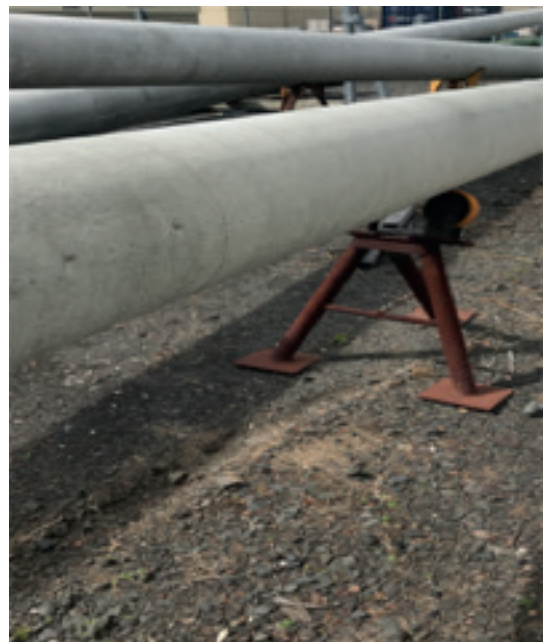
It was also observed multiple items of the tripod type pole stands in use that were damaged and there was no means of ensuring the stands not used. Damage included bent base plates, rusted / corroded components, no designed or supplier's information available regarding the use and maintenance of some of these stands.

Checklists for inspections to detect any equipment faults and assess the condition of these stands should be developed along with a safe system of work that includes having regular inspections of the dead man stands in line with the manufacturer's documentation.
