PLATFORM STEPS FOR POLE TRUCK UNLOADING

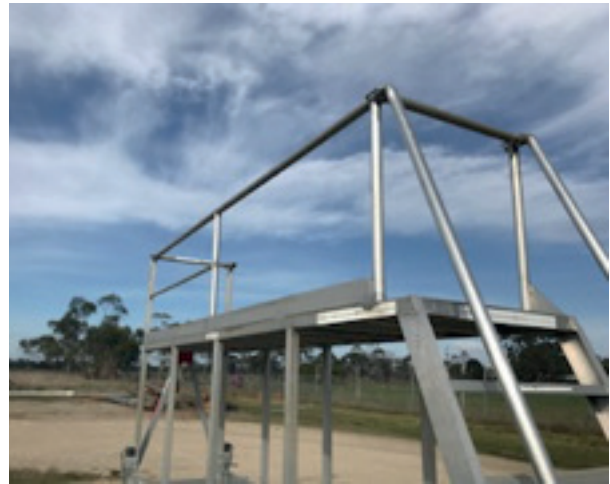
This alert has been generated to ensure that all workers in Victoria are aware of the risks associated with non compliant and non maintained platform steps. The platform steps shown below was recently seen in service at a pole yard on a safety walk conducted at a Downer Utilities site in Beaconsfield with the Electrical Trades Union and Management. The steps had a broken mid rail and no service record.

Checklists for inspections to detect any equipment faults and assess the condition of all platform steps should be developed along with a safe system of work for unloading poles that includes having regular inspections of the platform steps in line with the manufacturer's documentation.

If any of the above cannot be verified the work **should cease**. Contact your designated Health & Safety Representative, your local organiser or alternatively your Union OH&S Officer.
